## CROWN POULTRY, DUNCAN'S FARM CASE STUDY

### EQUIPMENT INSTALLATION REPORT:

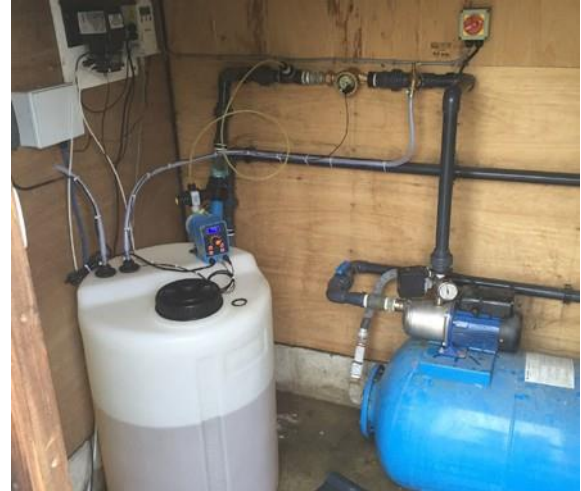
FIG. 1: Installed System

The installation was completed on the 26/5/2015 by Piers Maltby and Ryan Linley (Ximax Engineers). The DT200 system was installed in the main pump house controlled by a 4K Pulsed Water Meter fit onto the 1¼" UPVC pipe work, there was no requirement for backflow protection as there is a preinstalled non return valve on the head of the pump and the system is fed by a water tank with a type A-B Airgap.

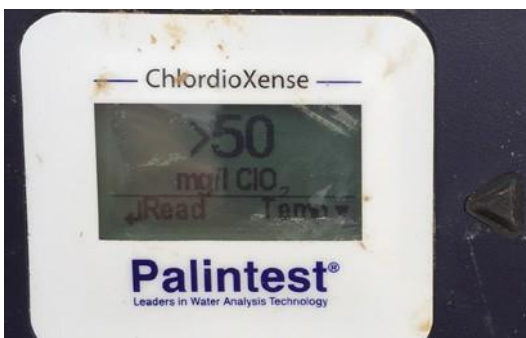
FIG 2: 50ppm Dosed In

The dosing system was adjusted to continuous mode and XzioX was injected into the water system for the whole site at a rate of >50ppm. This was held in the system under pressure for the period of 14 hours and released from the system the following day (27/5/15) when residual readings were taken of 10ppm. This process begins the breakdown of biofilm within the lines and creates a less attractive environment for further bacteria to thrive in. The loss of over 40ppm in a 14 hour period suggested that there was a very high bacterial count within the lines prior to the flush and that there was a very high amount of biofilm in the water system.

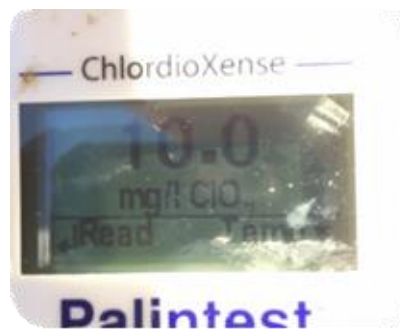
FIG 3: 10ppm Flushed Out

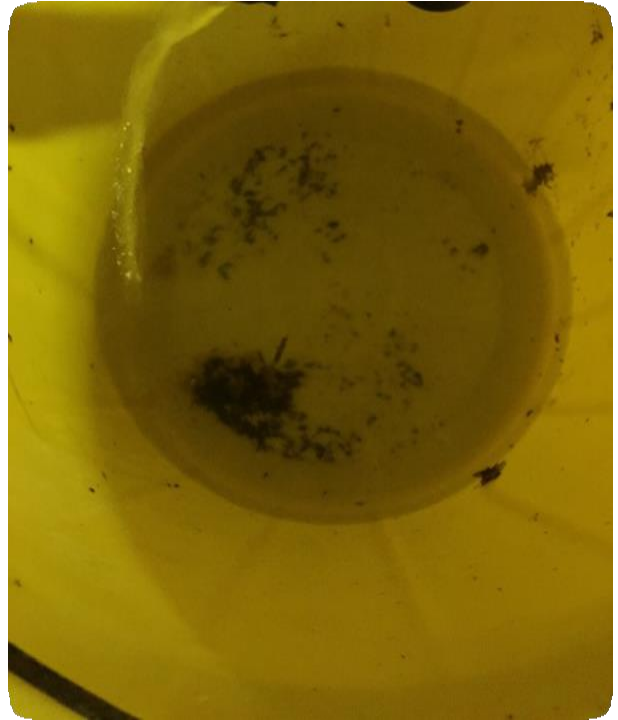
FIG 5: Biofilm Present in Flush

The high dose of XzioX was then flushed out of the system to gain a working residual value of 0.5ppm at the end of the lines throughout the site, and all sight glasses were mechanically cleaned to remove as much stubborn biofilm as possible. There are no filters on site to clean. Site was visited periodically throughout the next crop to ensure that residual levels were correct and to take bacterial samples in association with the site vets.

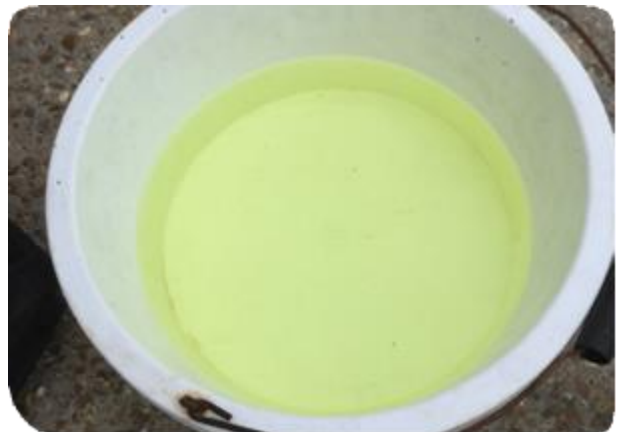
FIG 7: Flushed Water
